# ANT-1776ZB update of both partitions

Occasionally at power-on the ANT-1776ZB will boot into an alternative firmware version, 2.5.3.5, and not the 1.0.9.1 that is expected. A Power cycle of the ANT-1776ZB will cause the ANT-1776ZB to reboot and load the correct firmware version.

To prevent this from happening, both "partitions" need to be updated with the same firmware. This document is a quick guide to the update process.

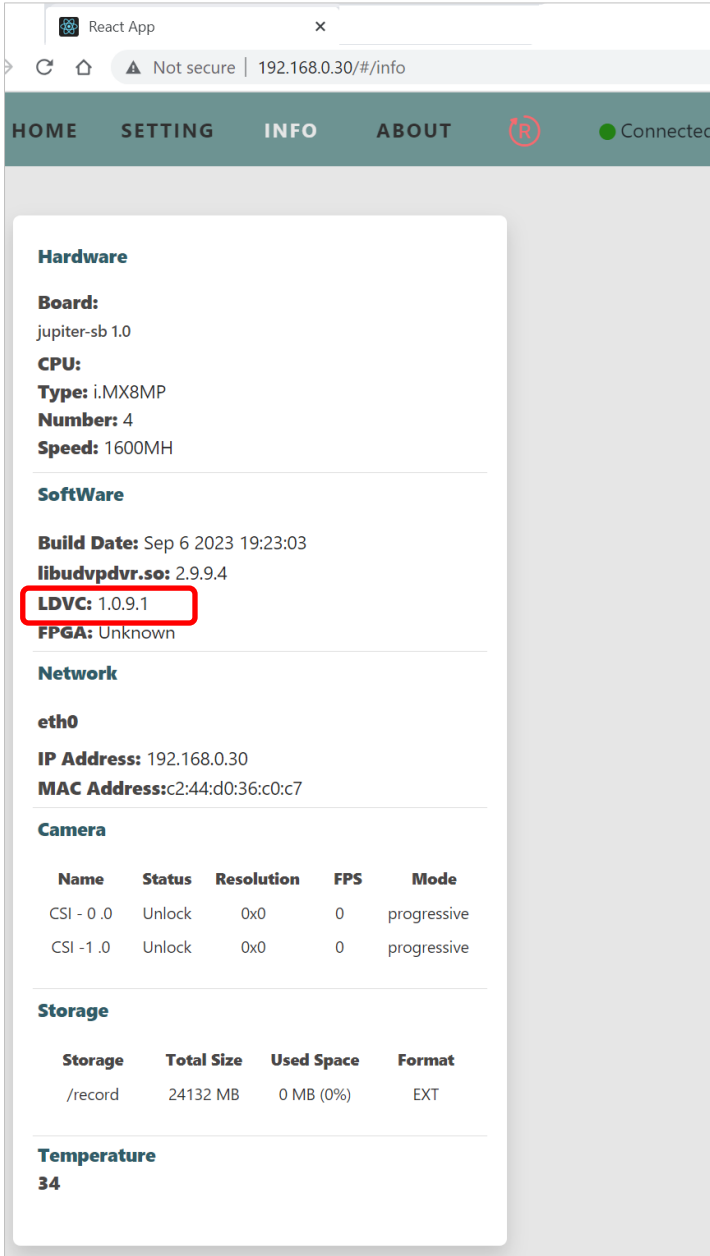
Figure 1 : ANT-1776ZB with f/w 1.0.9.1

In Figure 1 is the web page showing the current firmware version of 1.0.9.1. The alternative firmware version is not available from the webpage, see Figure 2, show what this alternative firmware version and the webpage associated with it. If this alternative firmware version webpage is seen a power cycling ONLY the ANT-1776ZB will cause the correct 1.0.9.1 to be booted.
