Upgrading an ANT-2504/2501 encoder to newer Firmware thus supporting the HUDL Sportscodes software.

HOW TO UPGRADE THE ANT-2504/2501 Encoder Firmware

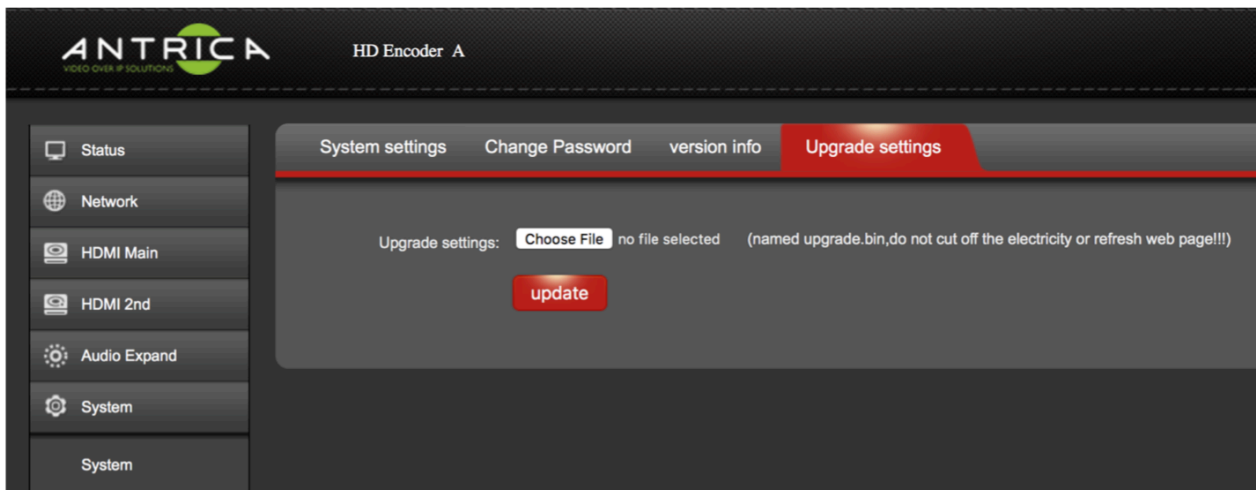
Please go to **SYSTEM / UPGRADE SETTINGS** using a modern web browser like Google Chrome

Click **CHOOSE FILE** and locate the **UPGRADE.BIN** file above

Click **UPDATE** and wait for the process to complete
